Section 2. Planetary Gear Drive Transmission

2.1 Transmission

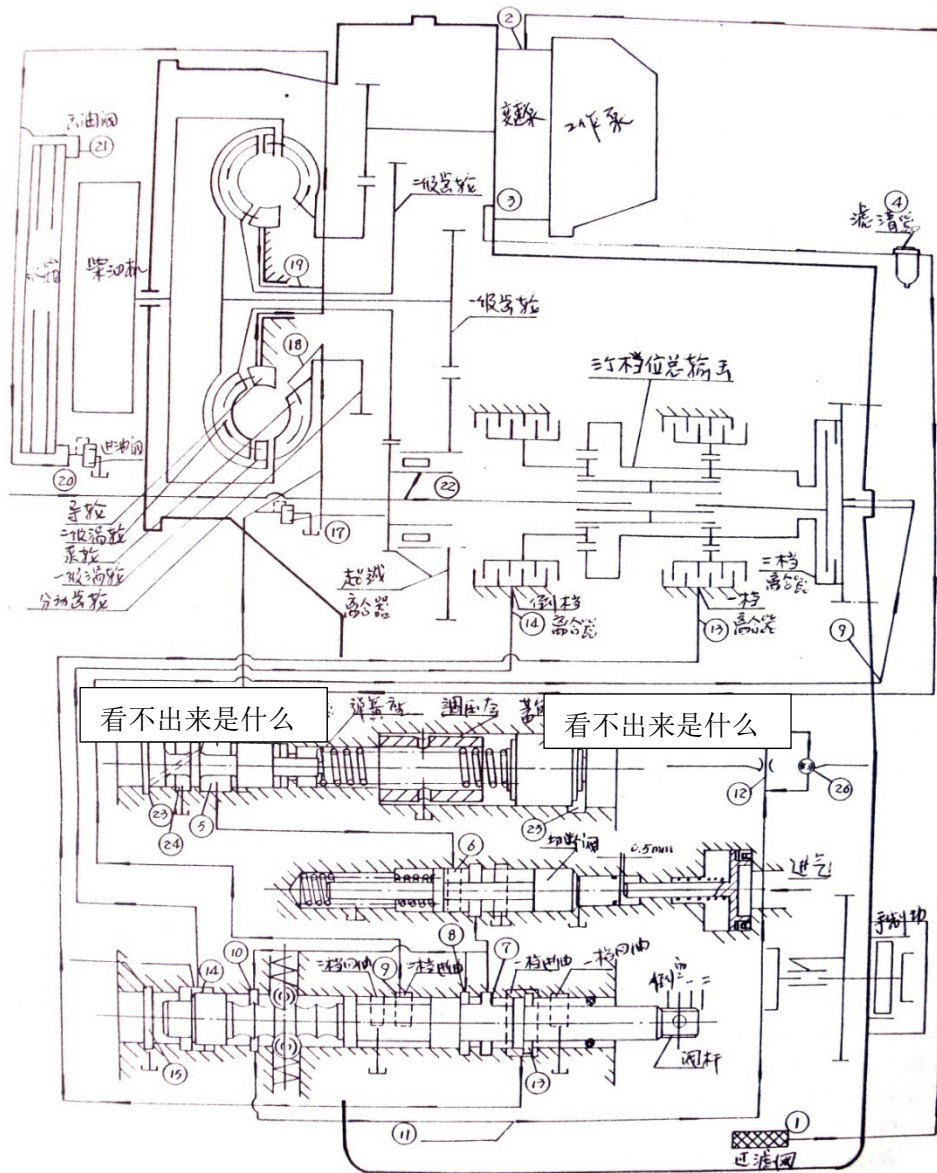
Illustration 2-18 Torque converter-transmission oil supply system

变油阀: oil valve of the transmission 油箱: oil tank 柴油机: diesel engine 变速泵: variable-speed gear
 工作泵: working pump 滤清器: filter 二级齿轮: second-stage gear 一级齿轮: first-stage gear
 一档离合器: first gear clutch 二档离合器: second gear clutch 倒档离合器: reverse gear clutch
 超越离合器: overrunning clutch 进油阀: oil inlet valve 切断阀: cut-off valve 一档进油: first gear oil inlet
 一档回油: first gear return oil 弹簧座: spring seat 调压阀: pressure regulating valve 进气: air inlet 过滤网: filter
 二档进油: second gear oil inlet 二档回油: first gear return oil 倒: reverse gear 空: neutral gear 过滤网: filter screen
 三个档位总输出: general output of the three gears 导轮: leading wheel 二级涡轮: second-stage turbine
 泵轮: pump gear 一级涡轮: first-stage turbine 分动齿轮: transfer gear 进油阀: oil inlet valve

As is shown in the Illustration 2-18, the work oil flows through the coarse filter screen 1, and then it is sucked in by the gear pump 2. The pressure oil from the gear pump 2 reaches the filter 4 through the oil passage 3 in the transmission body, and then enters the chamber of the pressure regulating valve 5. To ensure that the prioritized oil supply to different gears of the transmission, the oil in the chamber 5 flows into the chamber of the shut-off valve 6. If the shut-off is not at the shut-off position, the oil flows into the three chambers 7, 8 and 10 of the gear shift valve. The oil in the chamber 10 moves along the oil passage 11 in the speed distribution valve body, enters the right chamber 25 of the accumulation valve through the damper valve 12, and drives the accumulation piston (valve spool) to move leftward and compress the pressure regulating spring. When the oil pressure of the system reaches 1.1-1.5MPa, the pressure oil enters

the chamber 23 from chamber 5 through the small incline hole at the pressure regulating valve lever, drives the pressure regulating valve lever rightward, and compresses the pressure regulating spring from the two ends together with the accumulation valve spool. At this moment, the chamber 5 and the chamber 16 interlink, the pressure oil enters the oil inlet and overflow pressure valve 17 - the second pressure valve of the torque converter from chamber 5 and through the chamber 16, and then flows into the torque converter 18 to keep it working. Since there are clearances between different working wheels of the torque converter and the torque converter requires sufficient heat dissipation to continue normal operation, the oil entering the torque converter should be able to ensure the normal operation of the torque converter; in the meantime, the fluid flows out from the oil outlet 19 of the leading wheel base through the clearance between the leading wheel base and the second-stage output gear, enters the oil outlet valve (counterbalance valve) 20 of the torque converter through the outlet 21 of the heat radiator (water cooler since 1988) after it is treated in the heat radiator and to the lubricating overrunning clutch 22 and its bearing, and then flow into the transmission body 2 (oil reservoir). This is the torque converter-transmission oil supply process.
