SECTION 3 POWER TRAIN SYSTEM

GROUP 1 STRUCTURE AND FUNCTION

1. POWER TRAIN COMPONENT OVERVIEW

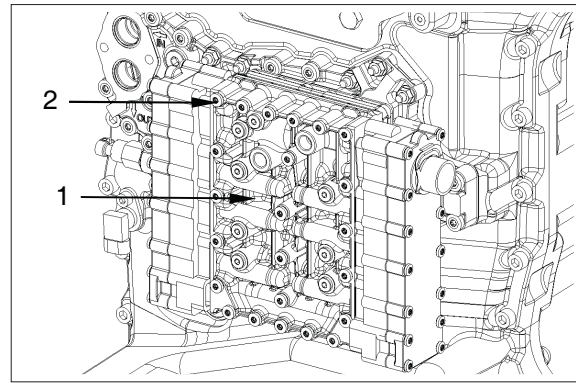
HL940TM003

- ② Remove gear-shift control assy (1) and sealing plate (2).

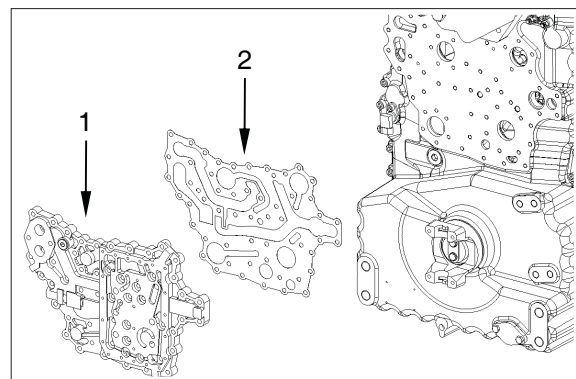
HL940TM006

- ⑤ Pull converter safety valve (1) out of housing hole.

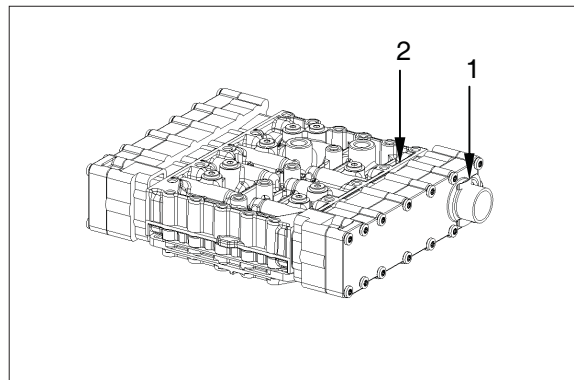
HL940TM008

- ⑦ Loosen Torx screws (1).

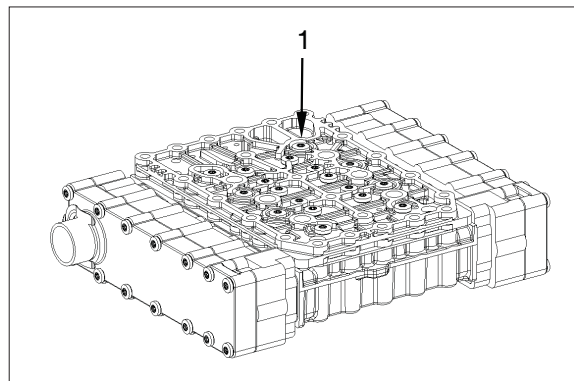
HL940TM009

- ⑧ Separate duct plate (1) and sealing plate (2) from valve block (3).

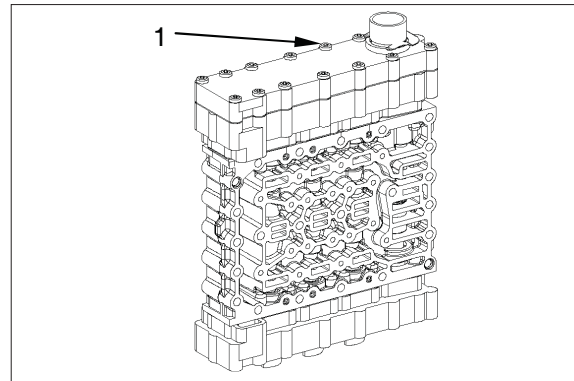
HL940TM011

- ⑩ Loosen Torx screws (1) and remove cover (2).
Remove opposite cover (3) in the same way.

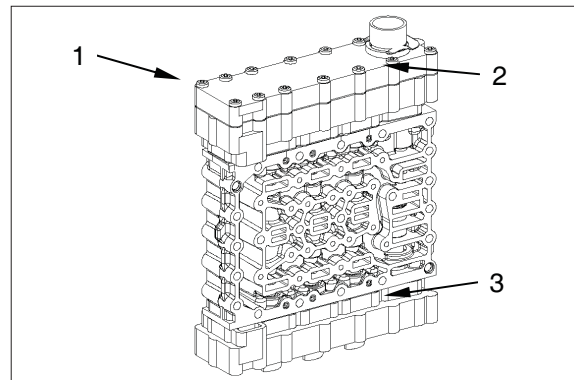
HL940TM012

- ⑪ Remove wiring harness (1).

Loosen cylindrical screws (3), remove fixing plates and remove pressure controllers (2).

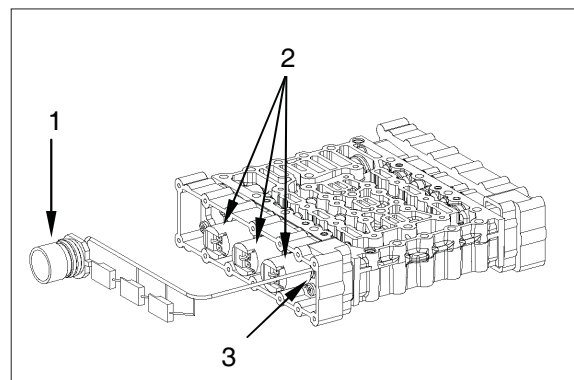
HL940TM013

- ⑫ Loosen cylindrical screws, remove fixing plates and remove pressure controllers (1) on opposite side.

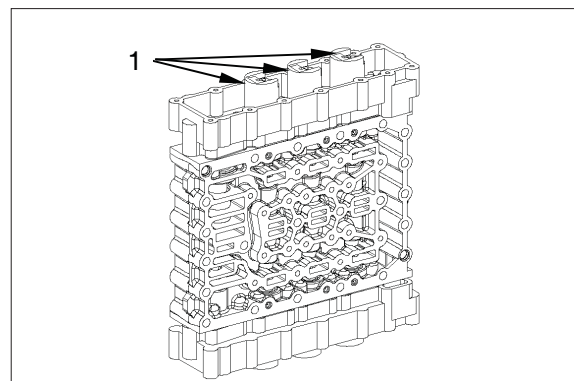
HL940TM014

- ⑬ Loosen two Torx screws (1) and preliminarily fix housing by means adjusting screws (S, housing is spring-loaded). Then loosen remaining Torx screws.

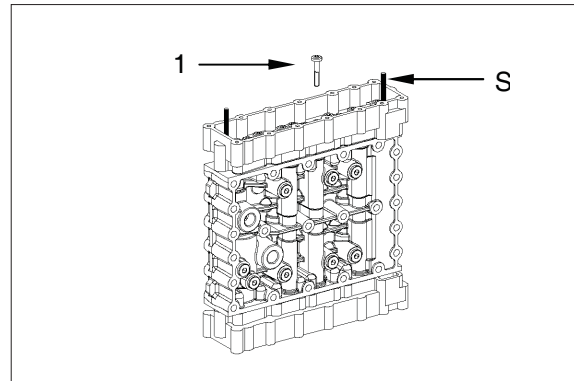
HL940TM015

- ⑭ Separate housing from valve housing by loosening the adjusting screws equally.

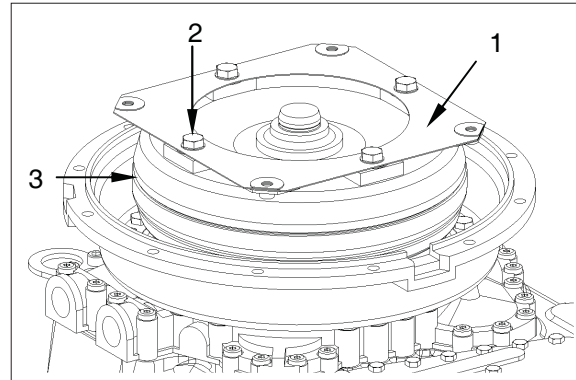
HL940TM021

- ② Separate converter (1) from transmission by means of lifting device.

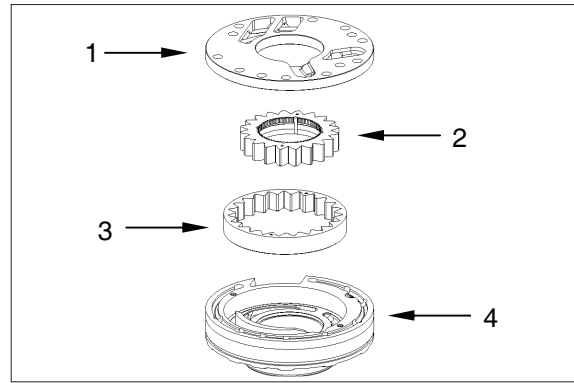
HL940TM034

⑤ Check oil gear pump :

In case of wear marks in the pump housing, cover or on the inner and outer rotor, the complete oil pressure pump is to be replaced.

- 1 Cover
- 2 Inner rotor
- 3 Outer rotor
- 4 Pump housing

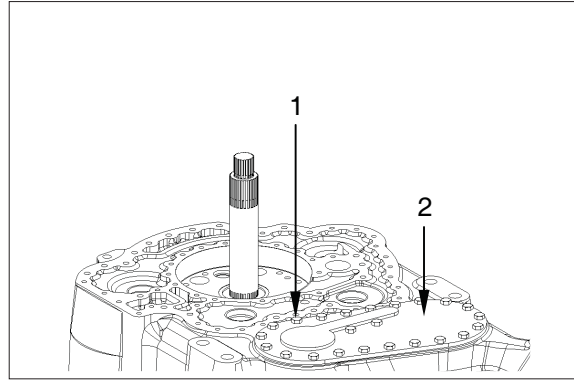
HL940TM040

(2) Version with emergency steering pump

- ① Loosen cylindrical screws (1) and separate emergency steering pump (2) from cover.
- ※ Mark radial installation position (see arrows).

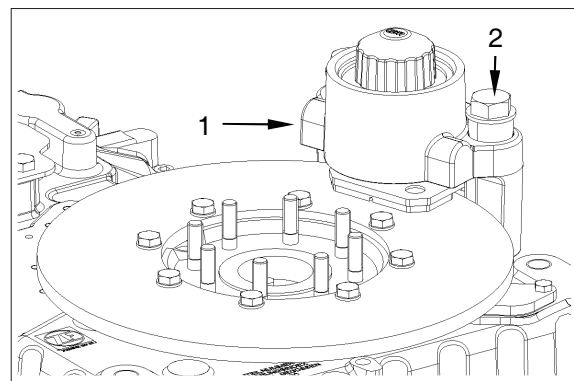
HL940TM058

- ④ Loosen hexagon screws (2) of bolted brake disk/output flange connection and remove brake disk (3).

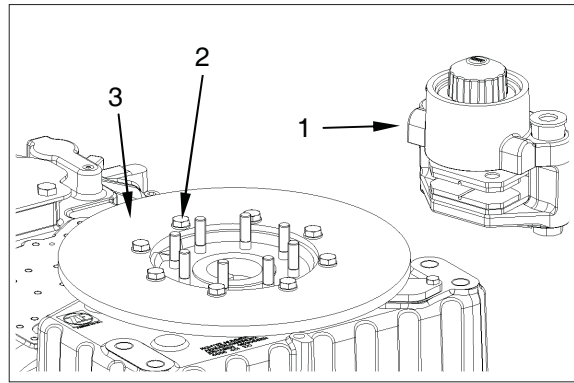
HL940TM059

- ⑤ Loosen hexagon screws (1), remove washer and O ring. Pull-off output flange (2) and remove shaft seal. Remove cylinder screw with washer (3).

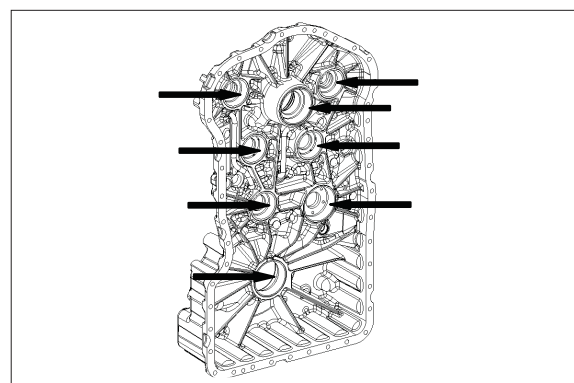
HL940TM087

(13) The lubrication lines are rolled in (1 and 2) and are highly difficult to remove. In case of damage, use of the appropriate special tool is imperative for fitting or replacing these components.

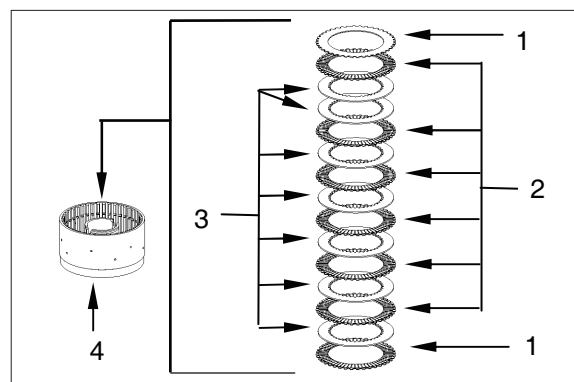
HL940TM193

⑮ Mount end plate (1) and fix disk package by means of snap ring (2) (e.g. thickness = 2.65 mm / recommended value).

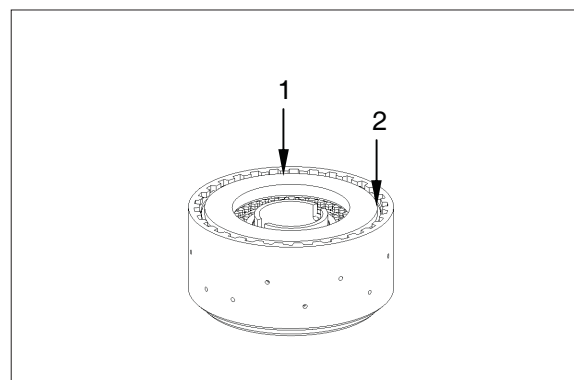
HL940TM194

- ⑩ Press on end plate with F (approx. 100 N = 10 kg) and set dial indicator to "zero".

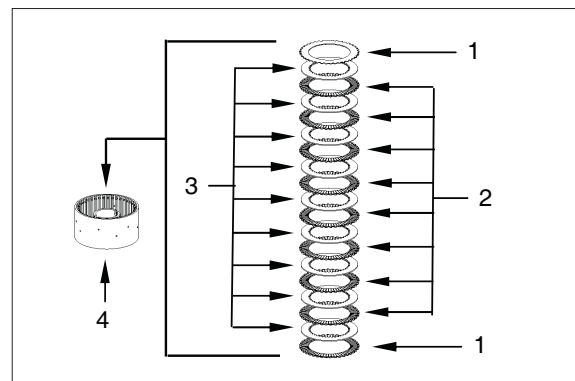
HL940TM234

- ⑩ Mount end plate (1) and fix disk package by means of snap ring (2) (e.g. thickness = 2.65 mm / recommended value).

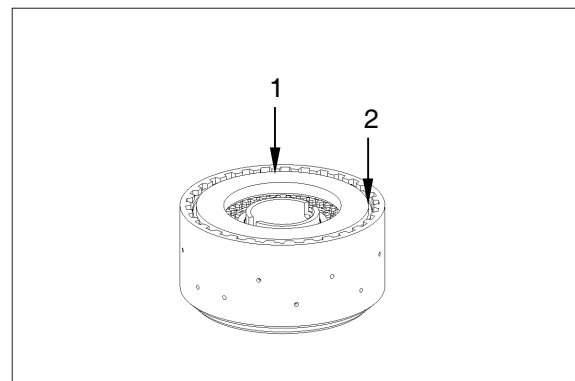
HL940TM235

- ⑪ Press on end plate with F (approx. 100 N = 10 kg) and set dial indicator to "zero".

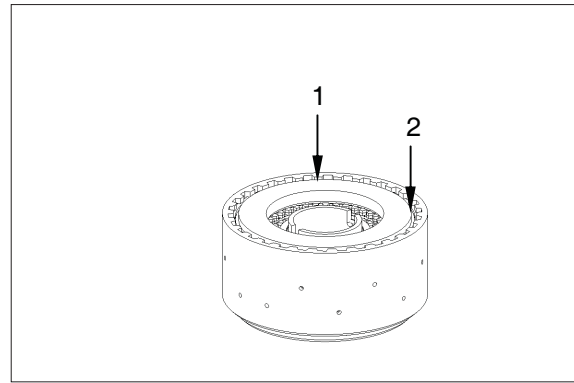
HL940TM257

- ⑩ Press on end plate with F (approx. 100 N = 10 kg) and set dial indicator to "zero".

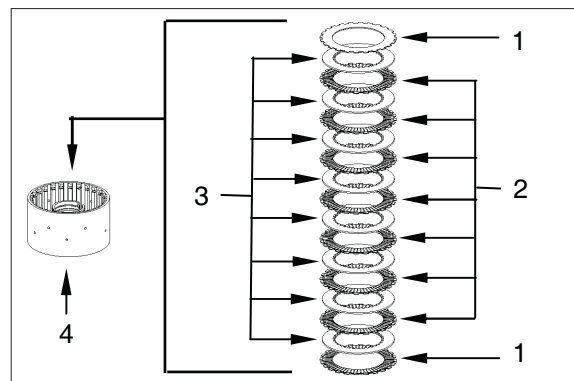
HL940TM278

- ⑨ Mount end plate (1) and fix disk package by means of snap ring (2) (e.g. thickness = 2.65 mm / recommended value).

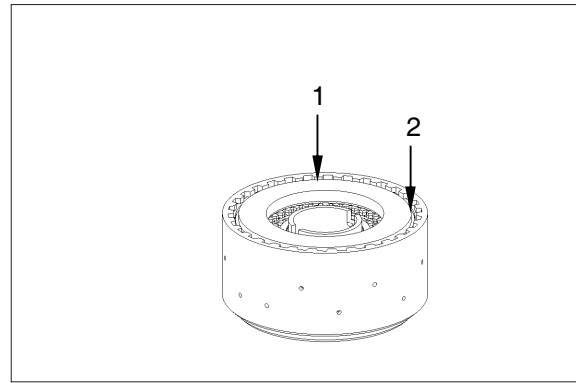
HL940TM279

- ⑩ Press on end plate with F (approx. 100 N = 10 kg) and set dial indicator to "zero".

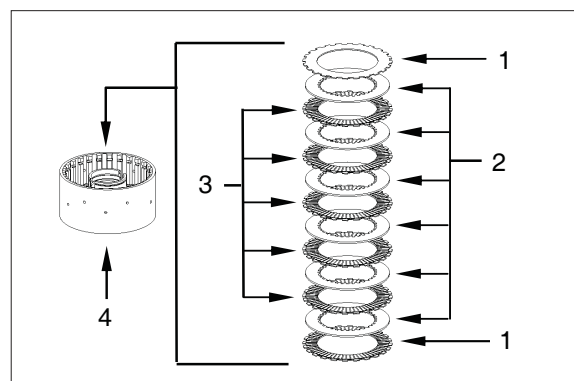
HL940TM307

- ⑩ Mount end plate (1) and fix disk package by means of snap ring (2) (e.g. thickness = 2.65 mm / recommended value).

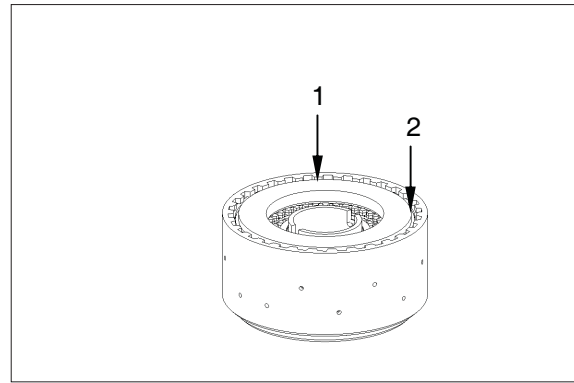
HL940TM308

- ⑪ Press on end plate with F (approx. 100 N = 10 kg) and set dial indicator to "zero".
