## SECTION 3 POWER TRAIN SYSTEM

## GROUP 1 STRUCTURE AND FUNCTION

### 1. POWER TRAIN COMPONENT OVERVIEW

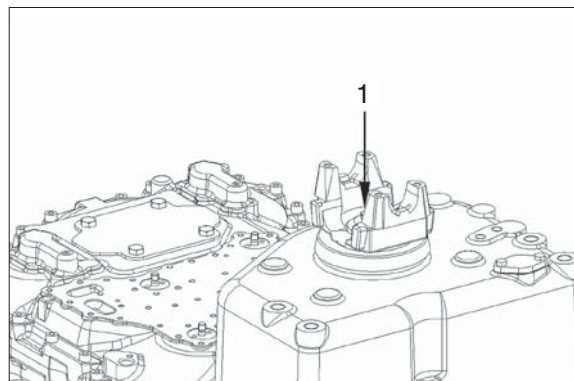
7609ATM038

- ② Pull off output flange (1) and remove shaft seal (2).

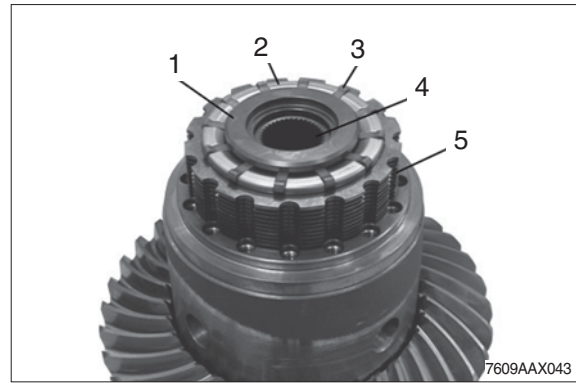
- 1 Pressure piece
- 2 Cage
- 3 Lever (12EA)
- 4 Disk carrier
- 5 Disk package
