## SECTION 3 POWER TRAIN SYSTEM

## GROUP 1 STRUCTURE AND FUNCTION

### 1. POWER TRAIN COMPONENT OVERVIEW

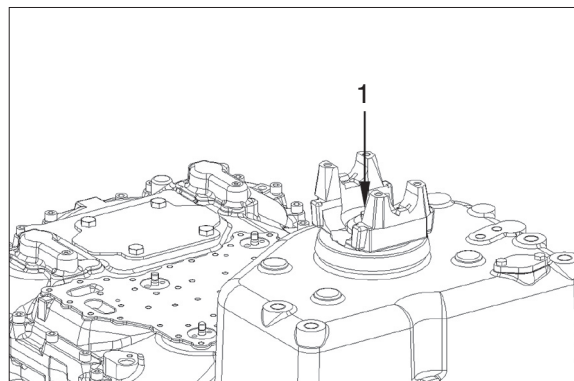
7609ATM038

- ② Pull off output flange (1) and remove shaft seal (2).
