SECTION 3 POWER TRAIN SYSTEM

GROUP 1 STRUCTURE AND FUNCTION

1. POWER TRAIN COMPONENT OVERVIEW

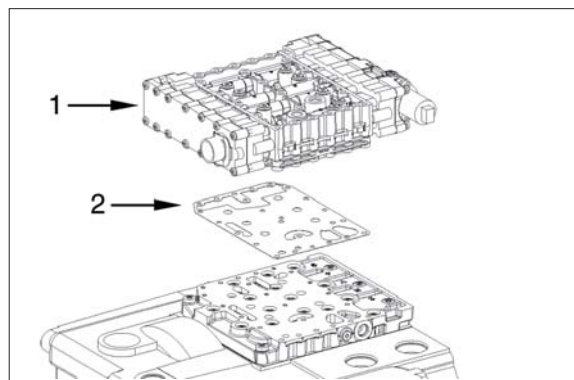
7709ACV03

- (4) Loosen torx screws and separate duct plate (1) and gasket (2) from gearbox housing.

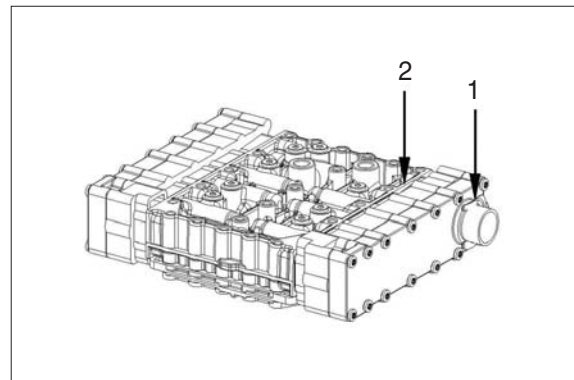
7709ACV05

- (6) Loosen torx screws (1).

Socket wrench TX-27 5873 042 002

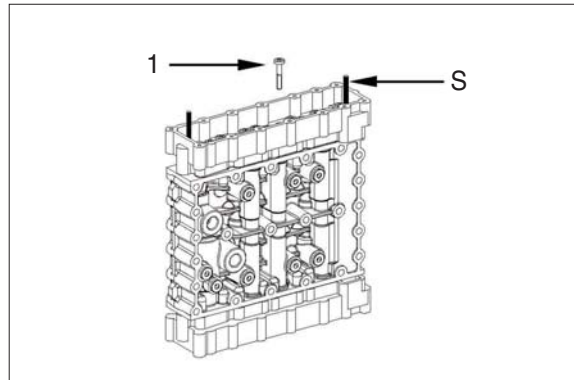
7709ACV13

(13) Separate housing from valve housing by loosening the adjusting screws equally.

Adjusting screws 5870 204 036

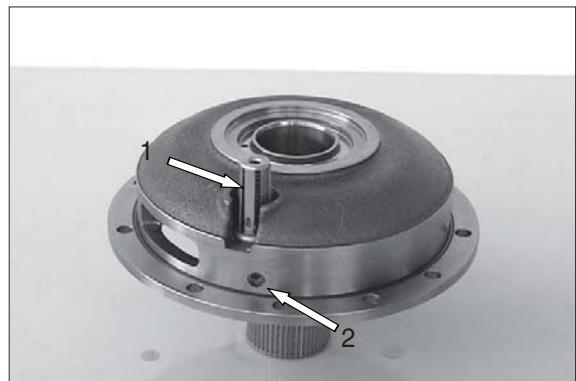
Figure 7

(5) Loosen the bolt connection (M8 and M12) and by means of lifting tackle and pry bar set separate the converter bell from the transmission housing.

※ Special tool
Eyebolts assortment 5870 204 002
Pry bar set 5870 345 036
Lifting chain 5870 281 047

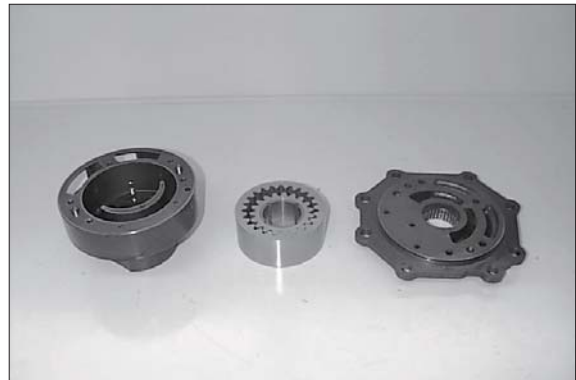
Figure 30

- Torque limit (M8/8.8) :
2.35 kgf · m (17.0 lbf · ft)
- Torque limit (M6/8.8) :
0.97 kgf · m (7.01 lbf · ft)

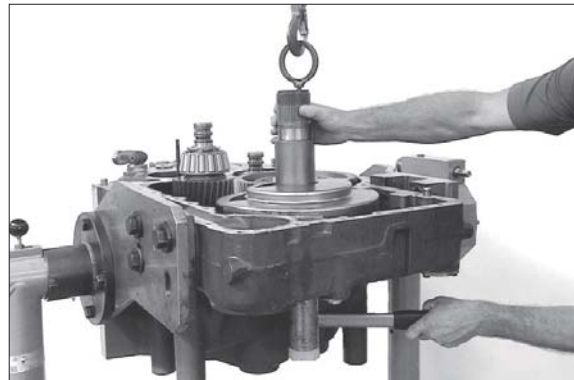
Figure 50

- (6) Loosen the hexagon screws and remove the oil baffle.
Lift the output gear out of the transmission housing (figure).

- ※ Special tool
Stop washer 5870 100 054
Eyebolts assortment 5870 204 002

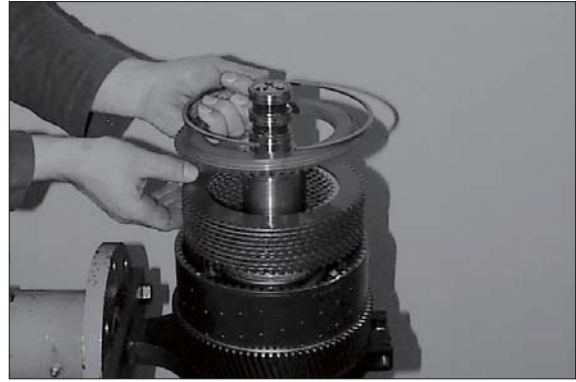
Figure 66

- (6) Rotate disc carrier by 90°. Loosen the slotted nut.

- ※ Special tool
Slotted nut wrench 5870 401 118
Slotted nut wrench 5870 401 115

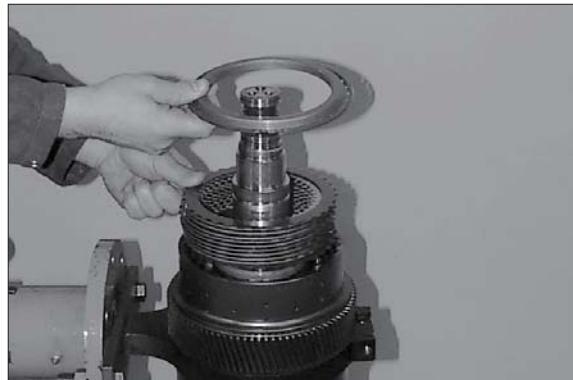
Figure 95

- (9) Rotate disc carrier by 90°.
Loosen the slotted nut.

- ※ Special tool
Slotted nut wrench 5870 401 118
Slotted nut wrench 5870 401 115

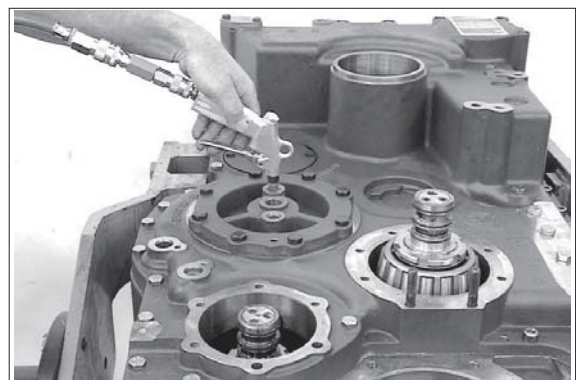
Figure 255

**Adjust the bearing preload of clutch KR/K2
= 0.0~0.05 mm (figure 258~262)**
