GROUP 2 MAJOR COMPONENT

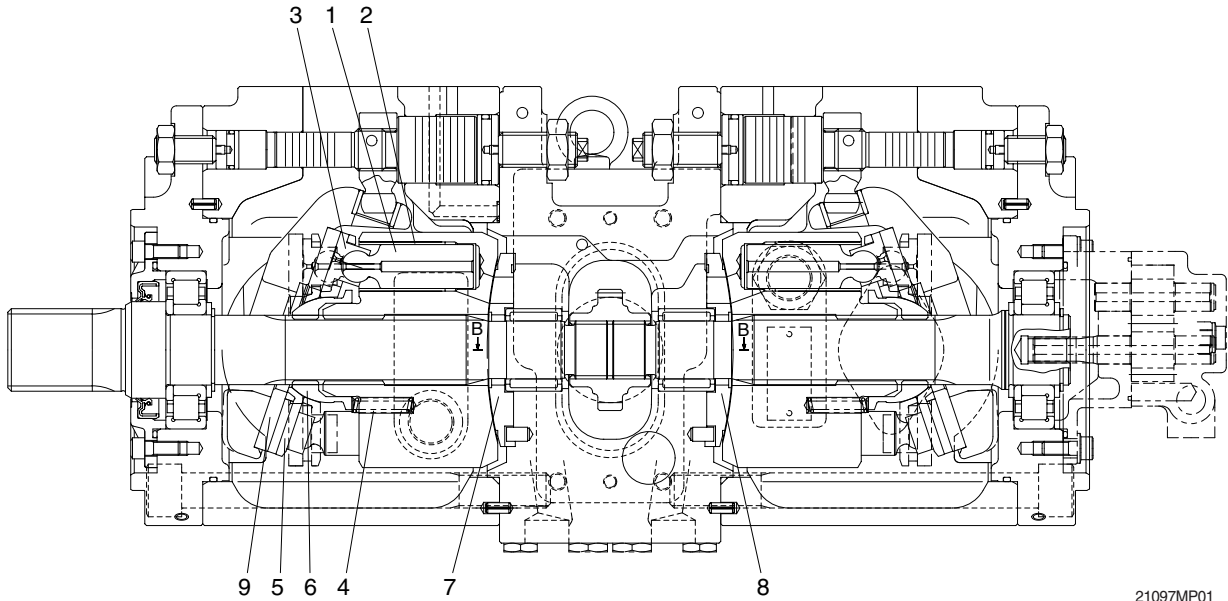
21097MP01

Part name & inspection item		Standard dimension	Recommended replacement value	Counter measures
Clearance between piston (1) & cylinder bore (2) (D-d)		0.039	0.067	Replace piston or cylinder.
Play between piston (1) & shoe caulking section (3) (δ)		0-0.1	0.3	Replace assembly of piston & shoe.
Thickness of shoe (t)		4.9	4.7	
Free height of cylinder spring (4) (L)		41.1	40.3	Replace cylinder spring.
Combined height of set plate (5) & spherical bushing (6) (H-h)		23.0	22.0	Replace retainer or set plate.
Surface roughness for valve plate (sliding face) (7,8), swash plate (shoe plate area) (9), & cylinder (2) (sliding face)	Surface roughness necessary to be corrected	3z		Lapping
	Standard surface roughness (corrected value)	0.4z or lower

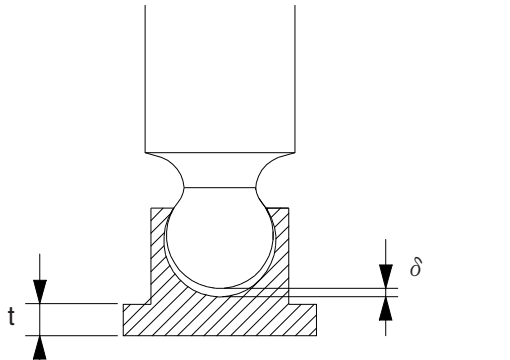
2507A7MS04		2507A7MS05

Inspection item	Standard dimension	Recommended replacement value	Counter measures
Clearance between piston and cylinder block bore	0.028	0.058	Replace piston or cylinder block
Play between piston and shoe caulking section (δ)	0	0.3	Replace assembly of piston and shoe
Thickness of shoe (t)	5.5	5.3	Replace assembly of piston and shoe
Combined height of retainer plate and spherical bushing (H)	6.5	6.0	Replace set of retainer plate and spherical bushing
Thickness of friction plate (h)	4.0	3.6	Replace

Part name	Standard roughness	Allowable roughness	Remark
Shoe	0.8-Z (Ra=0.2) (LAPPING)	3-Z (Ra=0.8)	
Shoe plate	0.4-Z (Ra=0.1) (LAPPING)	3-Z (Ra=0.8)	
Cylinder	1.6-Z (Ra=0.4) (LAPPING)	12.5-Z (Ra=3.2)	
Valve plate	0.8-Z (Ra=0.2) (LAPPING)	6.3-Z (Ra=1.6)
