GROUP 2 MAJOR COMPONENT

1. MAIN PUMP

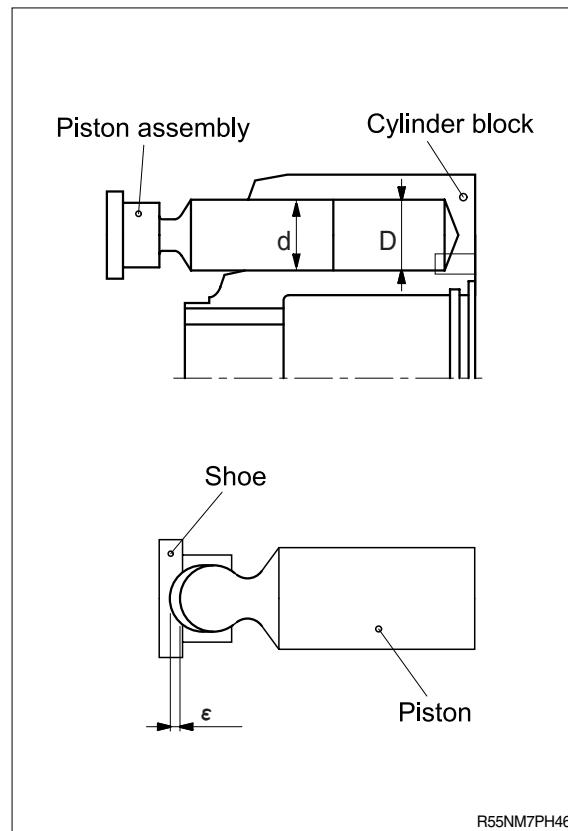
1) PISTON ASSEMBLY AND CYLINDER BLOCK

(2) Check the clearance between the piston outside dia and cylinder block inside dia.

$$D-d \leq 0.050\text{mm}$$

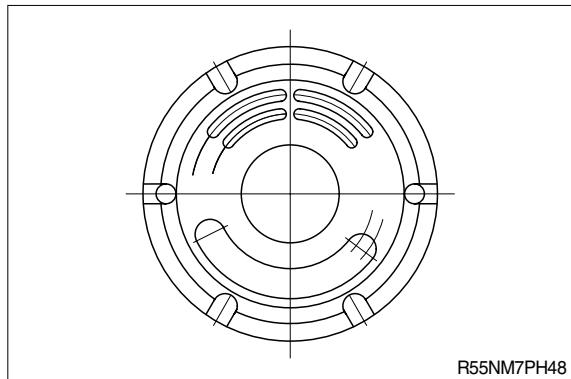
4) CONTROL PLATE

- (1) Check the slide surface for any damage.

When the damage is large, replace the plate with new one.

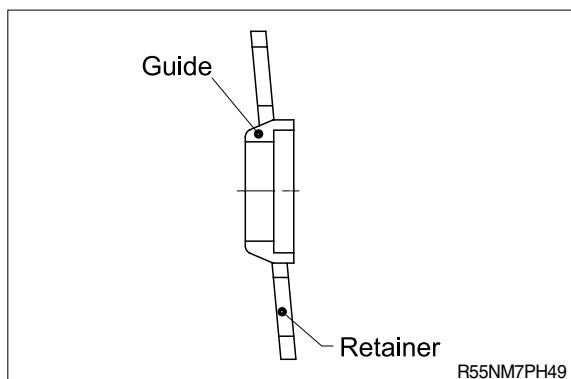
5) GUIDE AND RETAINER

- (1) Check for scouring or stepped wear.

If this can not be corrected, replace the guide and retainer with new full-set.

- (2) Fine scouring or damage can be corrected with lapping.

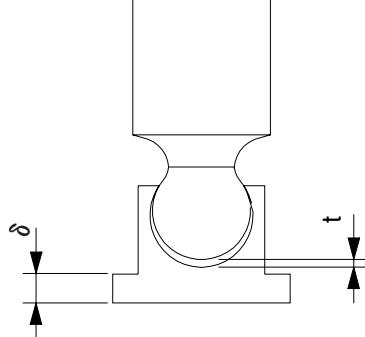
1) WEARING PARTS

Inspection item	Standard dimension	Recommended replacement value	Counter measures
Clearance between piston and cylinder block bore	0.020	0.045	Replace piston or cylinder block
Play between piston and shoe caulking section(t)	0	0.3	Replace assembly of piston and shoe
Thickness of shoe(δ)	4	3.8	Replace assembly of piston and shoe
Combined height of set plate and guide(H)	17.4	17	Replace set of set plate and guide
Thickness of friction plate	3.6	3.2	Replace
